Central Venous Catheter in the Internal Mammary Vein.

Anesthesiology, 131(2)

## Central venous catheter in the internal mammary vein

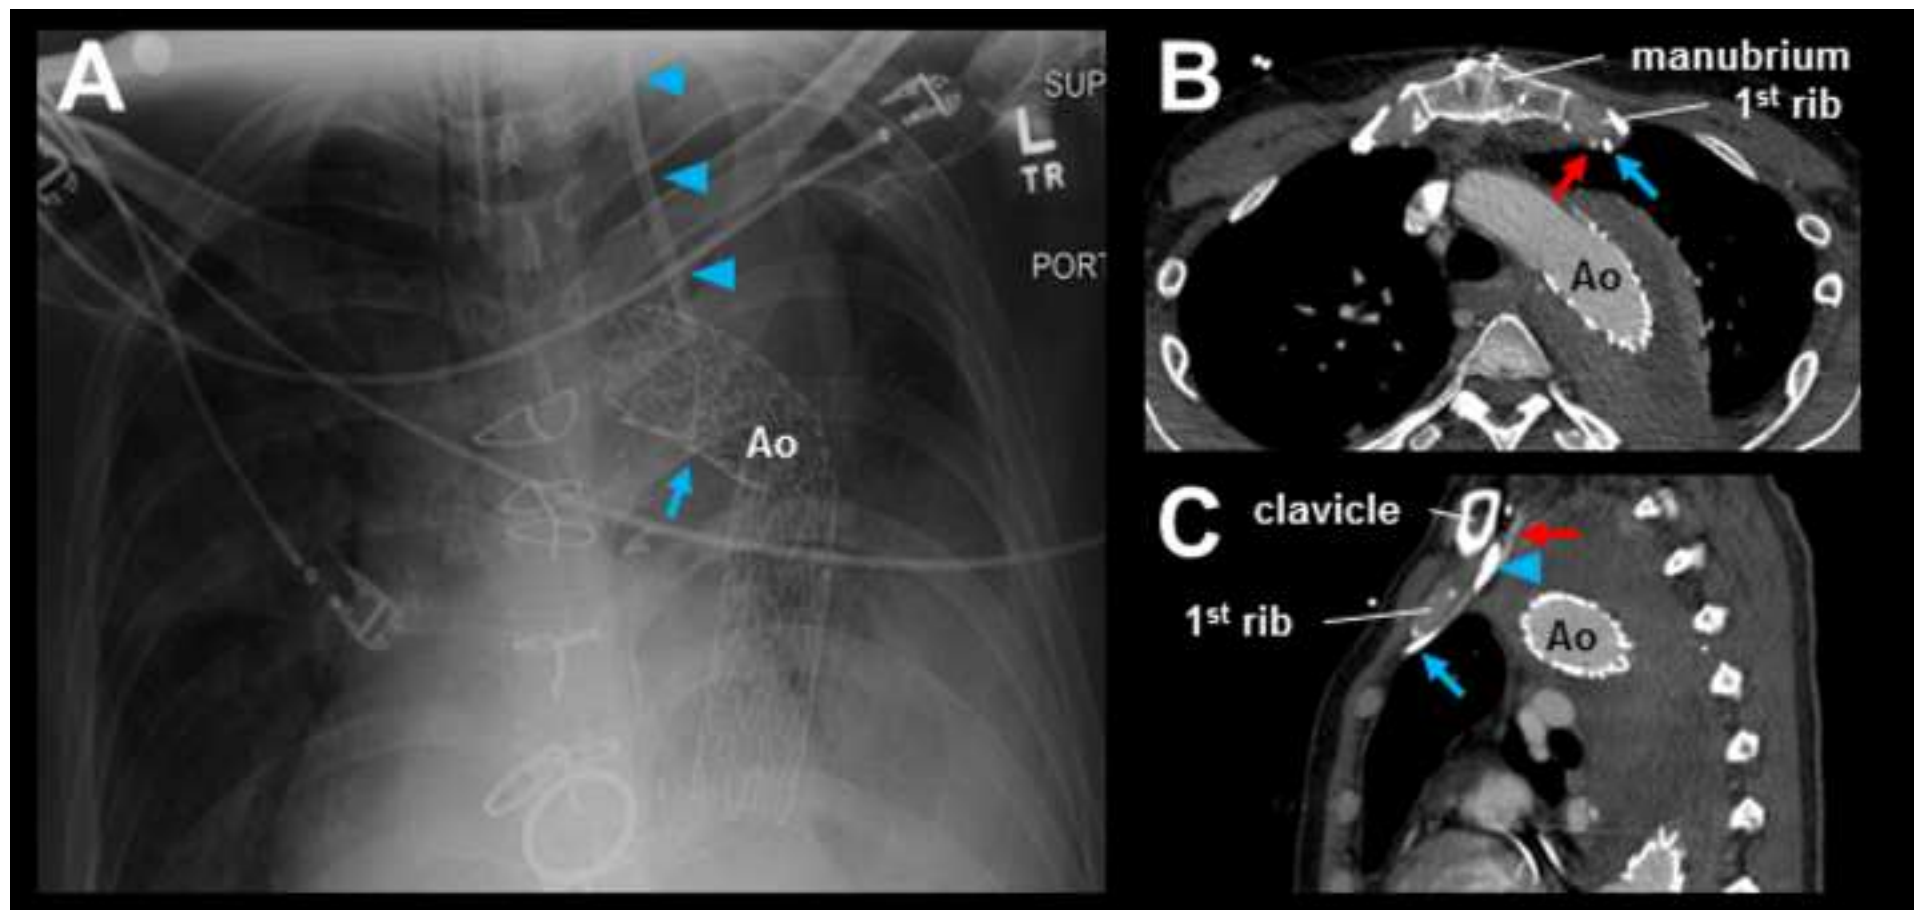
Left-sided central venous catheterization has several pitfalls. Malposition may occur despite proper insertion technique. Pictured here, a multi-lumen access catheter (sheath) with triple-lumen insert was placed by Seldinger technique after left internal jugular vein puncture. While initially freely mobile, the J-tip guidewire encountered resistance at 20 cm depth. The catheter advanced smoothly over the guidewire after dilation. Once secured, two distal ports would not aspirate; the remaining ports aspirated blood. A central venous waveform was transduced from the functioning ports, which were infused without complication. Chest radiography (Panel A) reveals the sheath position (arrowheads) with catheter tip (blue arrow) below the clavicle, concerning for **abnormal intravascular versus** intrapleural placement. **Sternotomy wires, prosthetic valves, left pleural effusion, and an aortic stent graft are also visualized.** Computed tomography angiography demonstrates cannulation of the left internal mammary vein (LIMV) without vessel injury (Panels B, axial and C, sagittal). The catheter runs alongside the left internal mammary artery (red arrows).

Anomalous vessel cannulation from left-sided supracaval approach occurs more frequently than right-sided. The left innominate vein returns at an oblique angle to the superior vena cava (SVC) and has tributary vessels (e.g., LIMV) which catheters may cannulate.<sup>1,2</sup> Risk factors include persistent left SVC, prior vascular surgery, tumors, and anomalous venous drainage.<sup>1</sup> Resistance to guidewire advancement or inability to aspirate blood from distal ports may indicate anomalous cannulation. High central venous pressure transduction and greater than four insertion attempts portend malposition.<sup>3</sup> **Partially withdrawing the sheath and rewiring under fluoroscopic guidance may offer a salvage technique.**
